Hamilton Field, Temporary Post Exchange  
(Facility No. 145)  
Hangar Avenue between San Pablo Avenue  
and Caliente Real  
Novato  
Marin County  
California

HABS No. CA-2398-D

WRITTEN HISTORICAL AND DESCRIPTIVE DATA

**HAMILTON FIELD  
Temporary Post Exchange  
(Facility No. 145)**

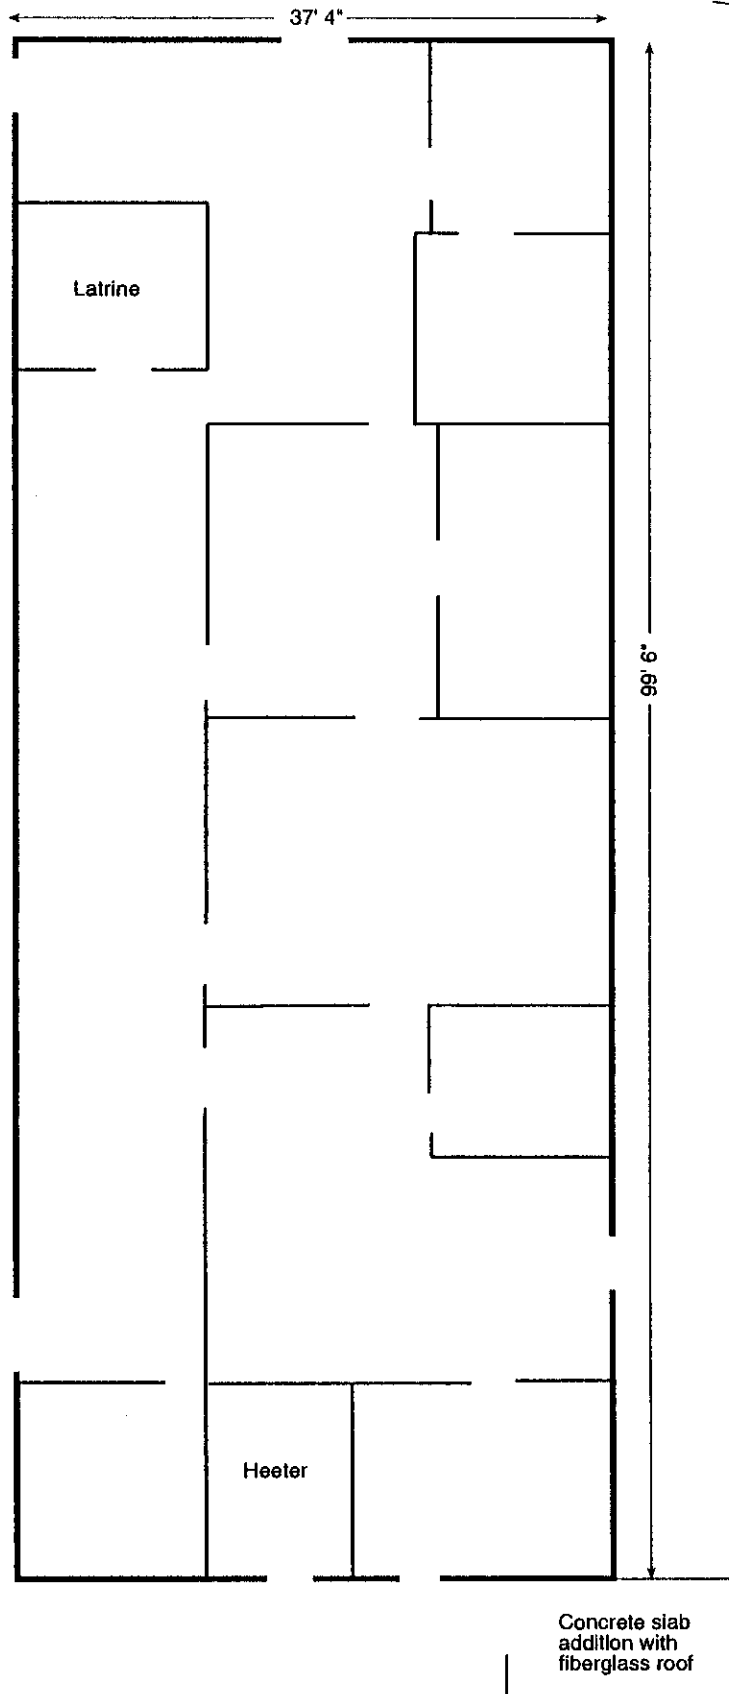
NOTE: Individual room function is unknown

This building was at one time the northwesternmost building in a World War II temporary housing area; all other associated buildings have been removed. Facility 145 is a rectangular (37 feet by 99 feet), one story frame building with a low-pitched composition gable roof with metal louvers on the east side. The truss system is composed of six-inch by 12-inch beams spaced six feet apart; each beam is supported by one-inch by six-inch braces. Four raised roof ventilators capped with sheet metal and a curved flue with a four-foot-high stack are present on the building. The original siding was 1-inch by 10-inch horizontal boards but it was covered with asbestos shingle siding in the mid-1950s. The building sits on a concrete foundation and a concrete ramp leads to a double door on the north side.

Exterior windows are double hung wood sash with six lights in each pane. The north and south facades, the long sides of the building, have six windows spaced around a double door. The west side has three windows and a double entry door and the east side has only one window and a single door. Doors are solid core wood with four-light pane over three recessed panels. Metal security lights holders are located to the side of the doors. A small concrete block addition with a corrugated fiberglass roof is located on the east side of the

The original flooring in the building was tongue and groove lumber; it is covered with eight-inch-square vinyl asphalt tile in a marbled red pattern. Walls are temporary wood partitions. One office in the northwest corner of the building is wood paneled. Some rooms have acoustical tile suspended ceilings but the majority of the offices have exposed roof beams. Original light fixtures were ceiling-mounted "schoolhouse" fixtures with milk glass bulbs. These are still present in the hallway but the offices have two tube fluorescent light fixtures with metal hoods suspended from the ceiling. Heat is through an exposed duct system.
